Sandhills Stream Restoration and Native Prairie Fishes

Tevyn Pieper – Sandhills Task Force

Plum Creek

Bear Creek

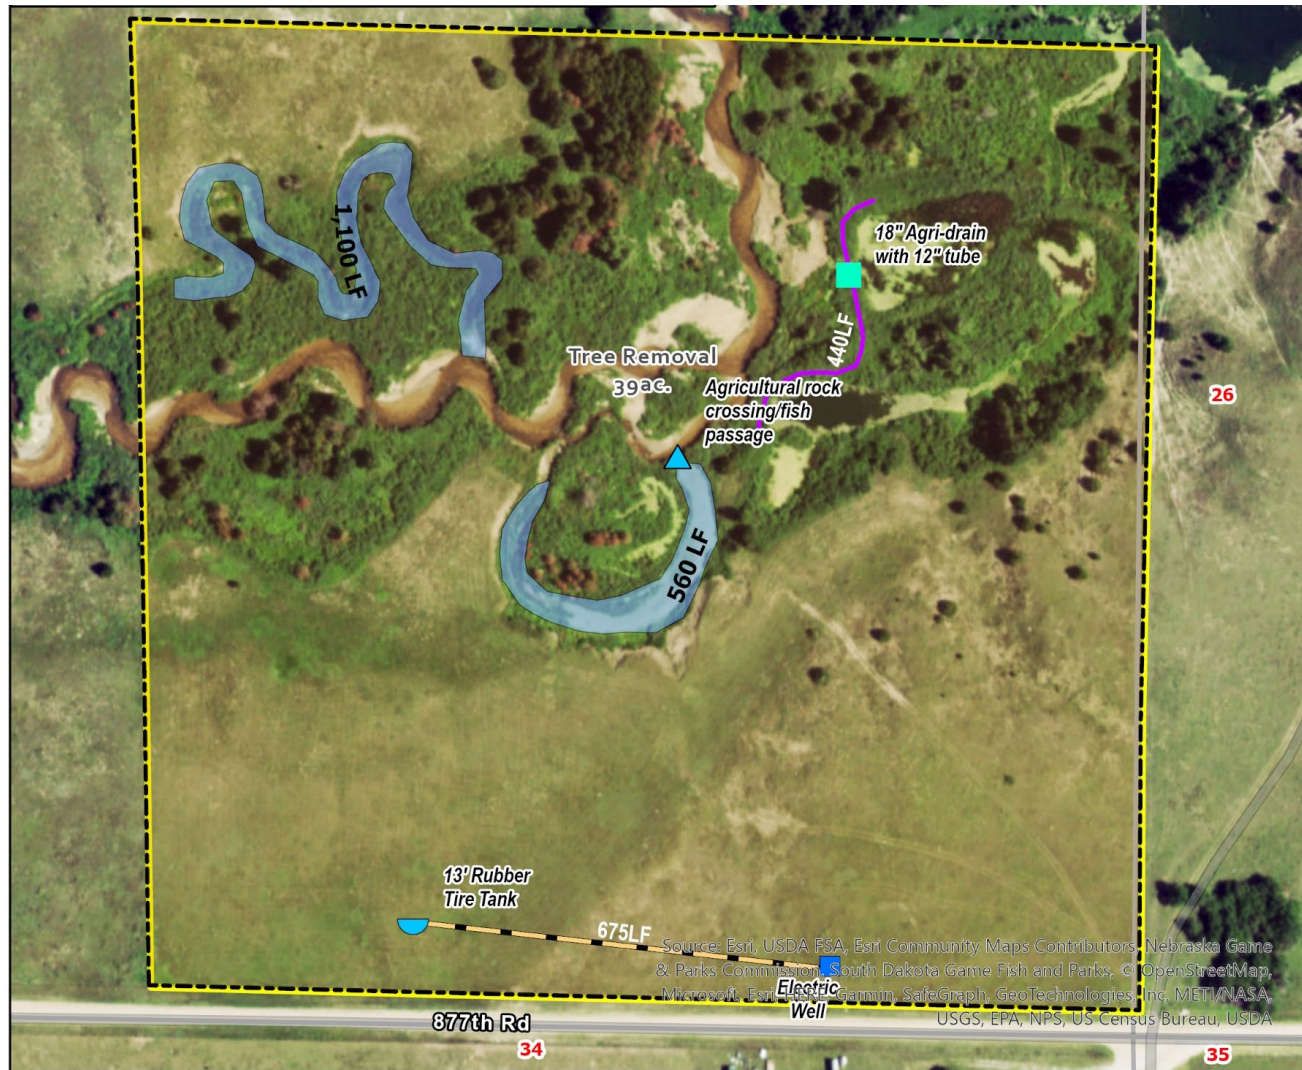
- Install rock-crossings
- Sediment removal
- Install Agri-drain
- Eastern Red Cedar Removal
- Provide off-stream livestock water

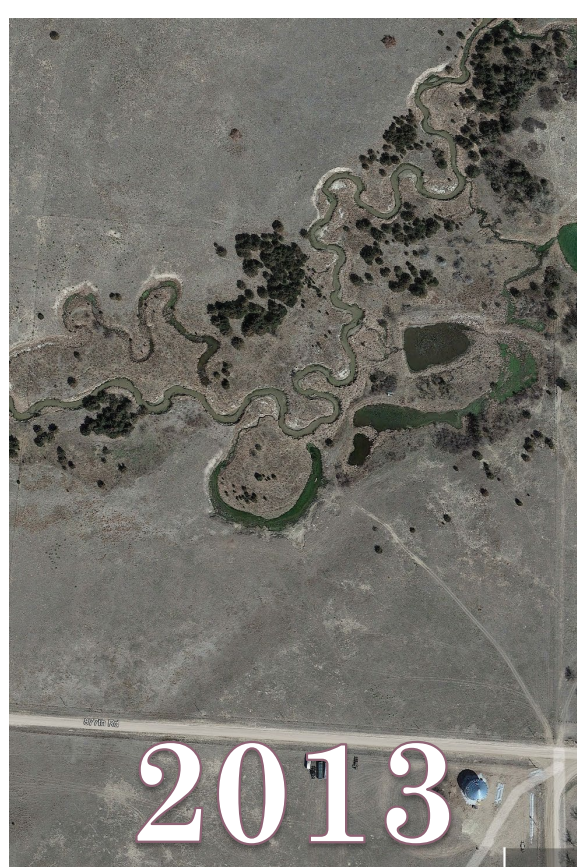
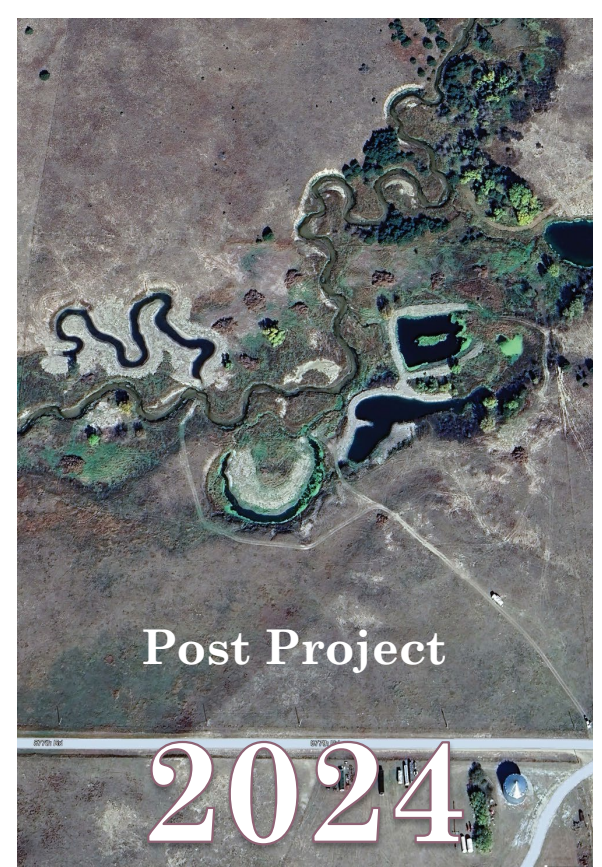
* Stream cut off
north slough and
south oxbow

- Shows how this reach of Plum Creek has evolved over time.

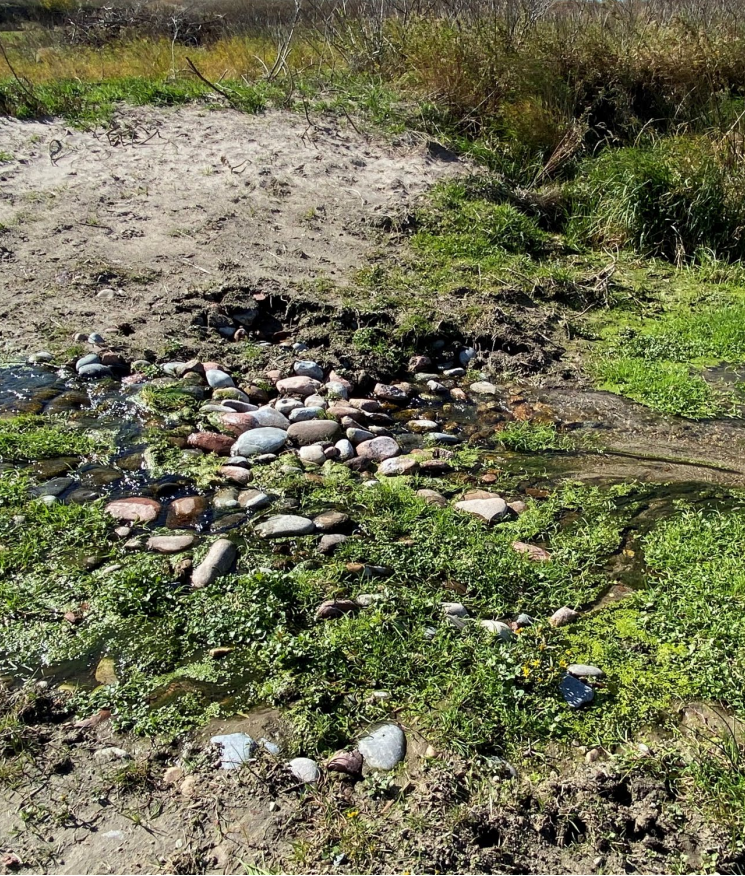
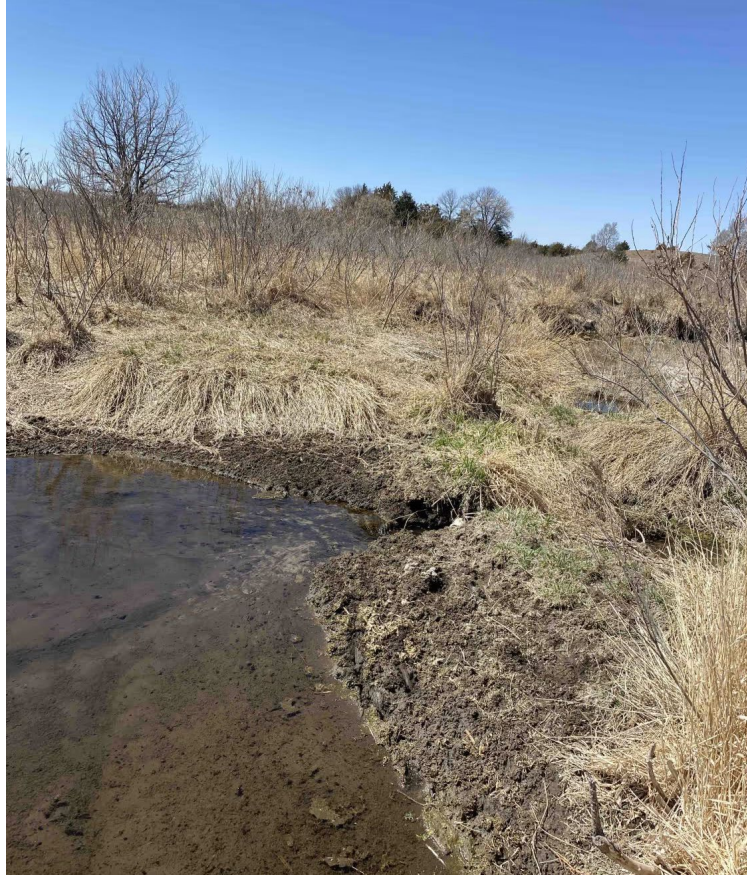
South Oxbow

- Installed low-water crossing/rock ramp
 - Allowed for Landowner to cross the south oxbow
 - Connected oxbow with active channel allowing for fish passage in/out of oxbow
 - Prevented further head cutting/drainage of oxbow

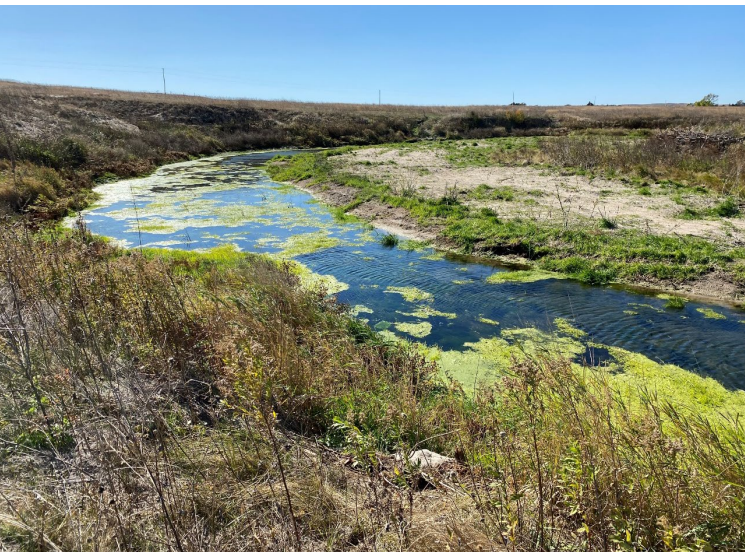
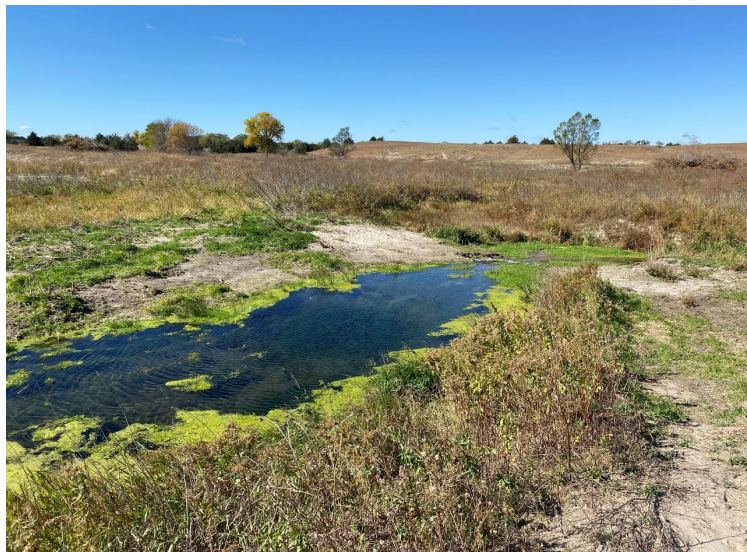
- Sediment Removal
 - Increased surface water and depth
 - Provide off-stream habitat for fish
 - Improve habitat for migratory waterfowl and shorebirds.

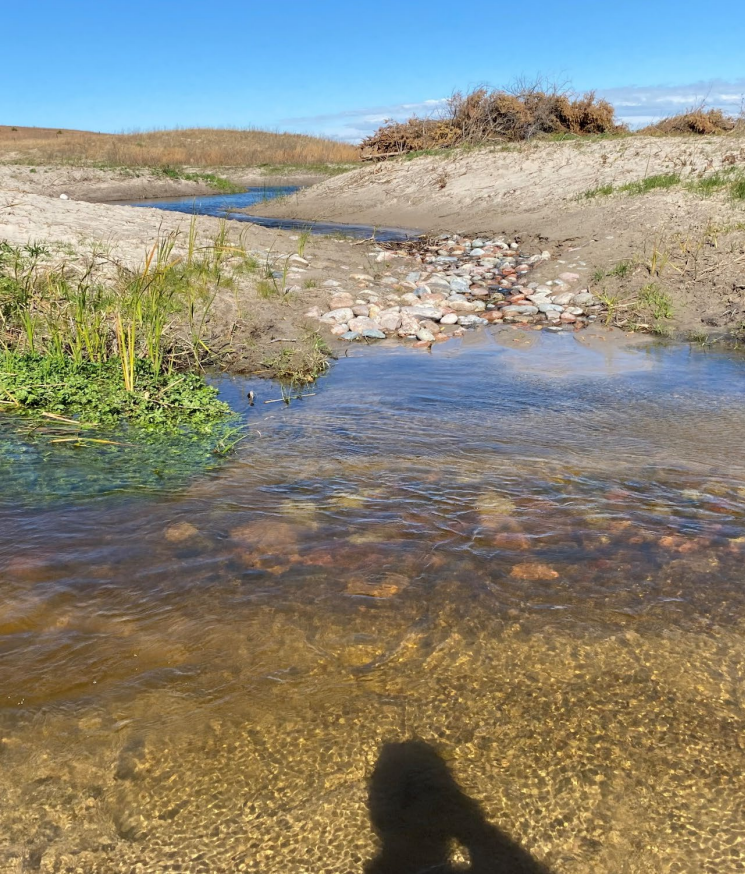
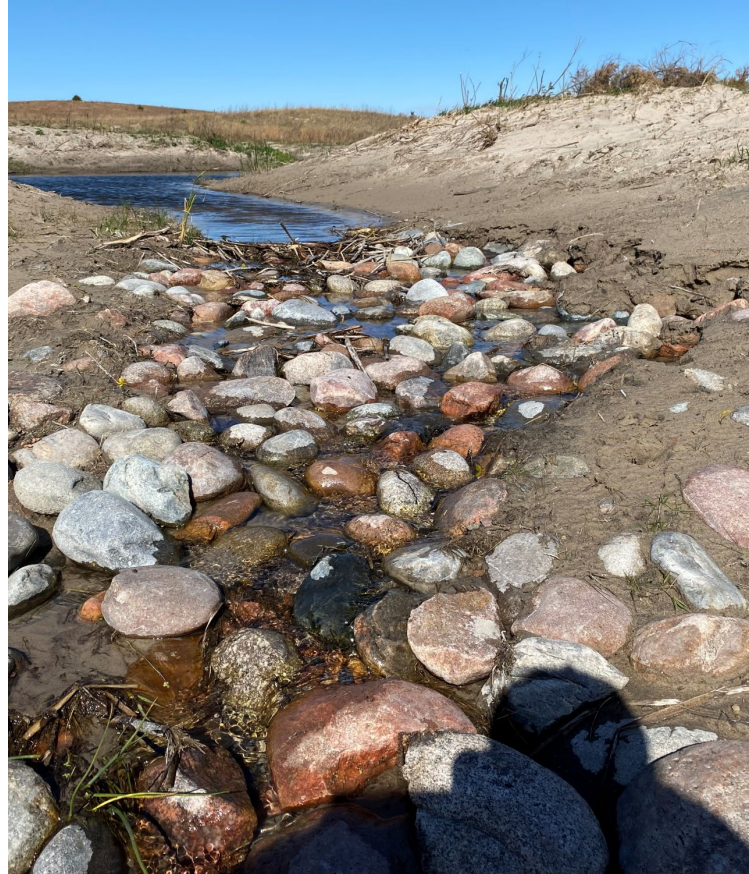
North Slough

- Installed low-water crossing/rock ramp
 - Captured higher surface water elevation in slough vs the creek
 - Connected slough with active channel allowing for fish passage in/out of
 - Serves as hard point -Preventing further head cutting/draining of slough

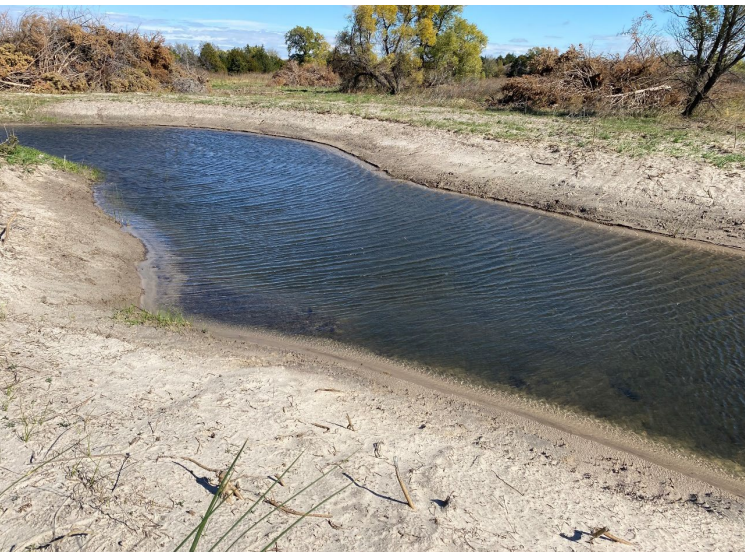
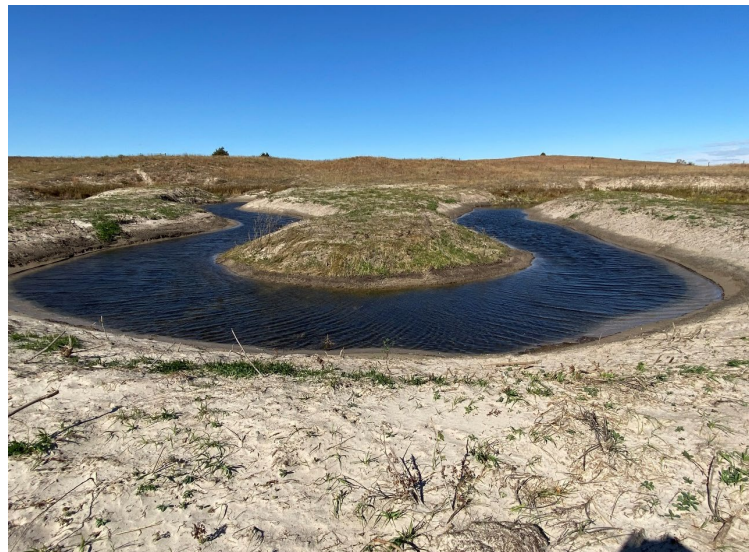
- Sediment/Cattail Removal
 - Increase width and depth of slough
 - Provide off-stream habitat for fish and other wetland dependent wildlife species
 - Improve habitat for migratory waterfowl and shorebirds.

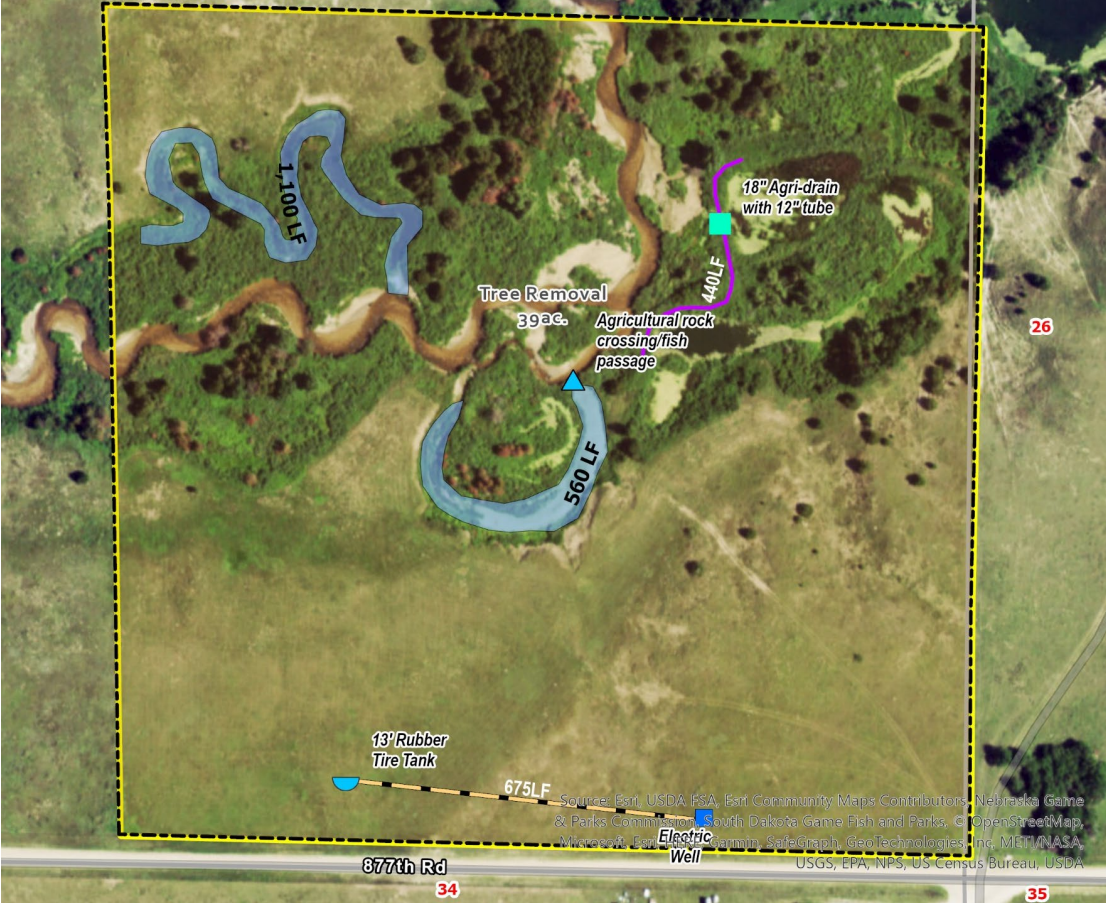
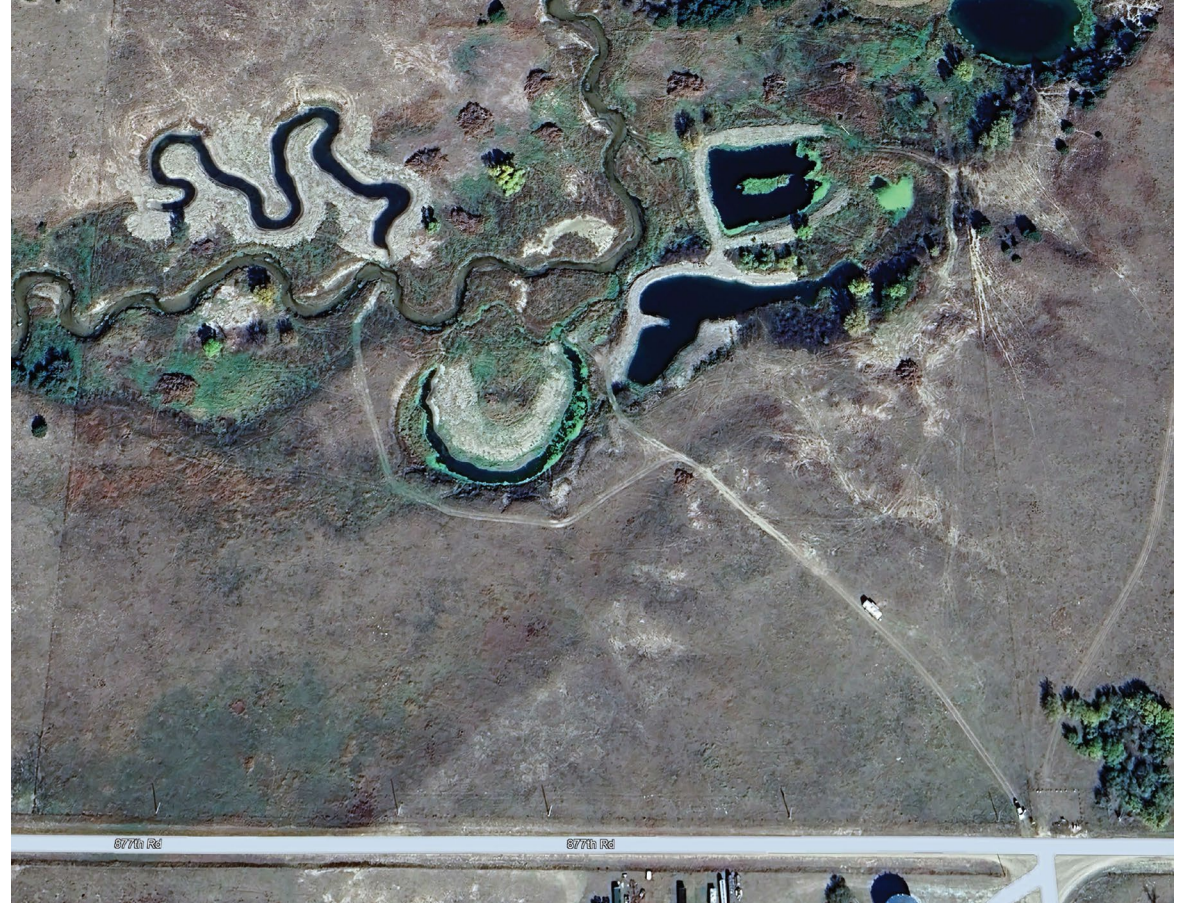
Design vs Finish Project

- Provided fish access to off-stream water features
- Enhanced/Restored of off-stream water features
- Provide tools to allow future wetland and upland management

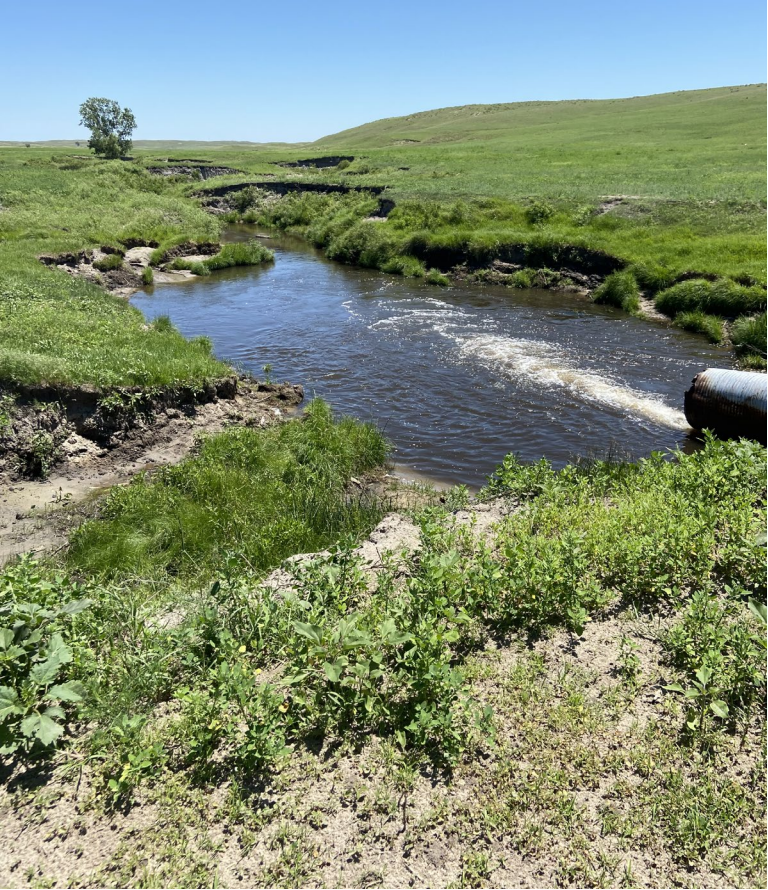
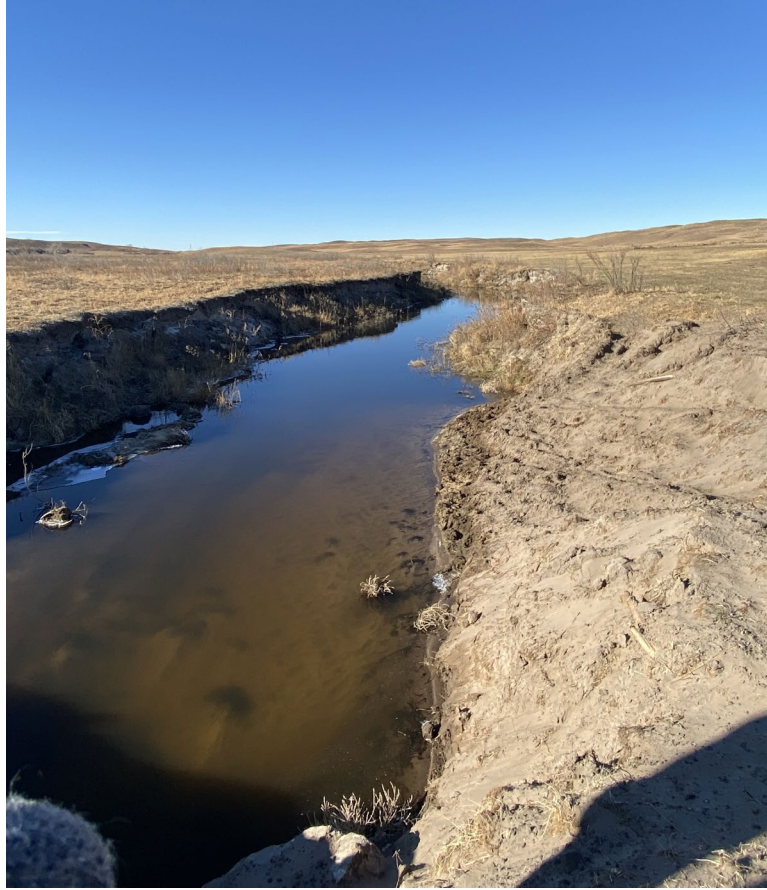
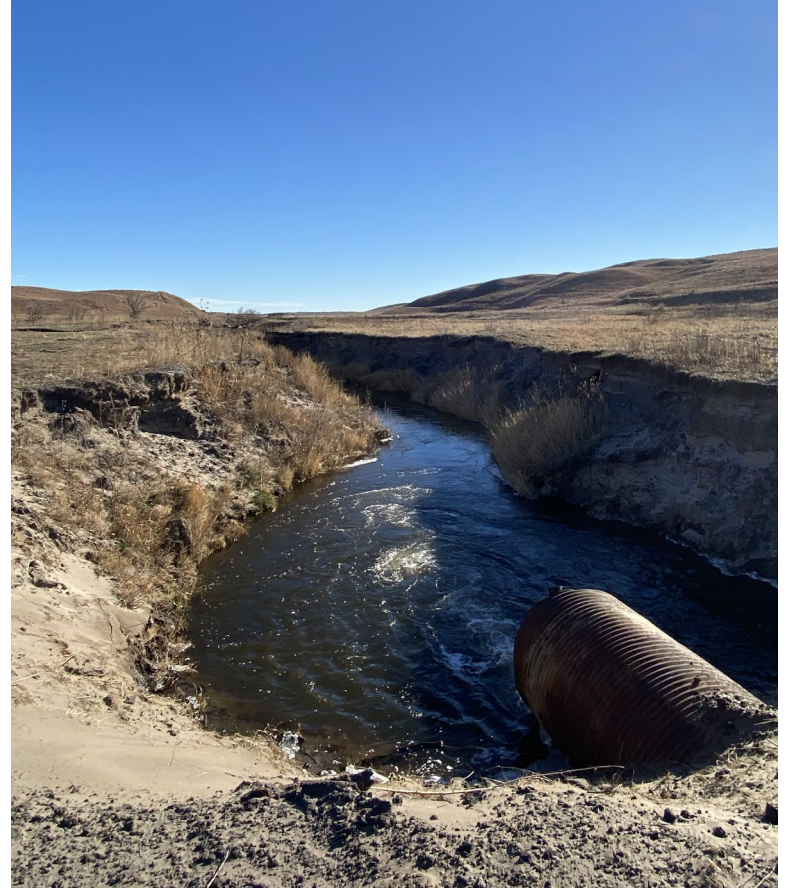
Fish Passage Concerns

- Small culverts
- Connectivity between culverts
- Erosion on banks
- Sediment

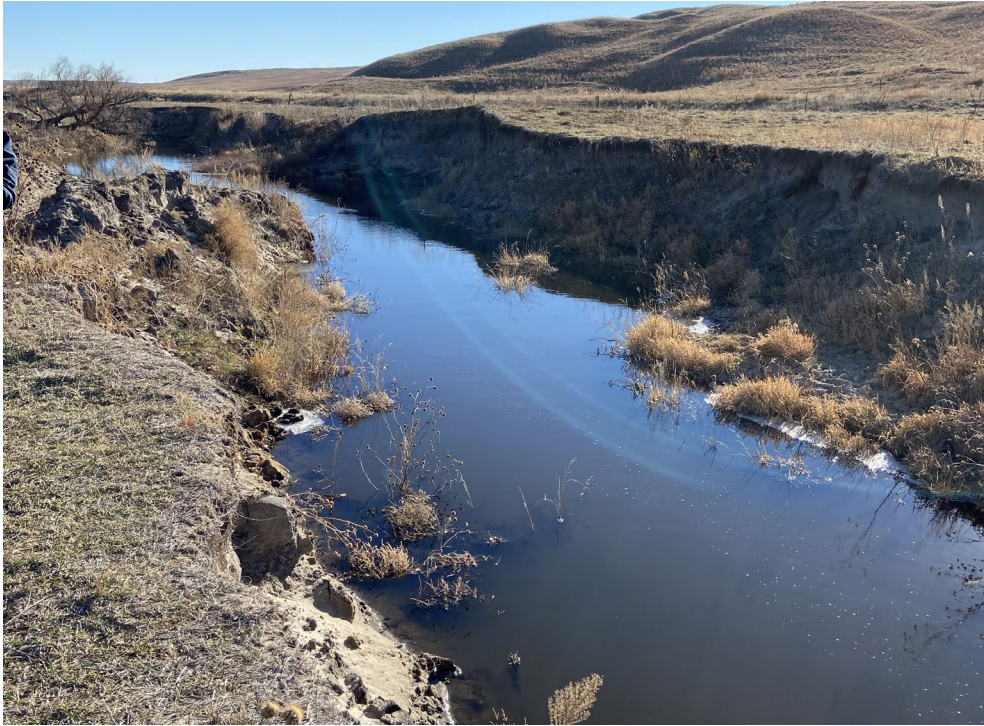
Before – Incising/Downcutting

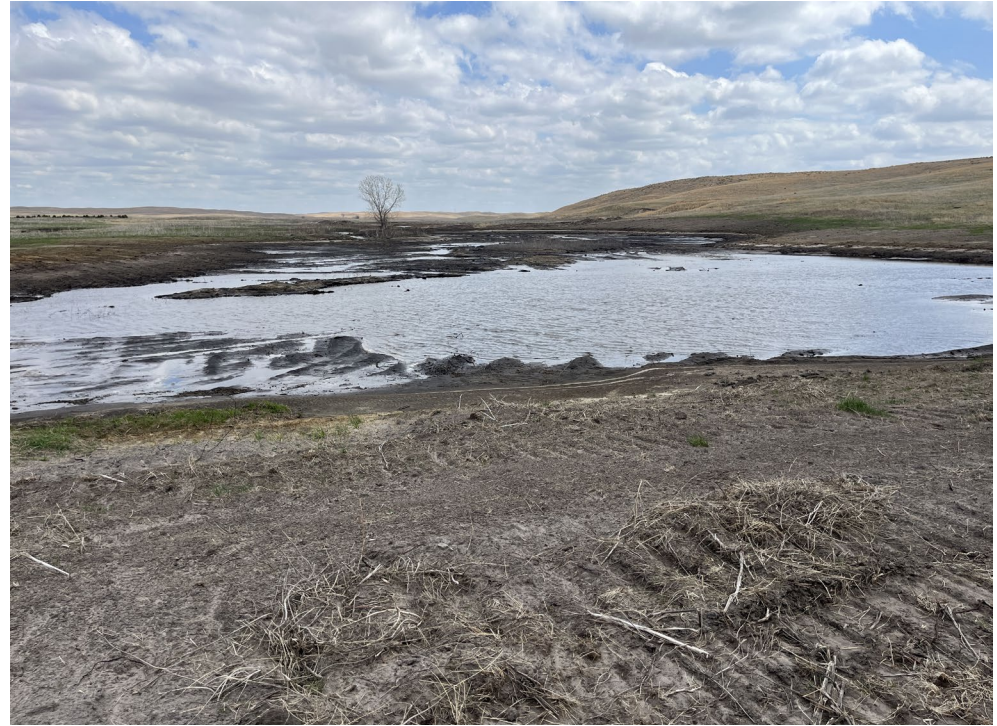
After – Slope Recontouring

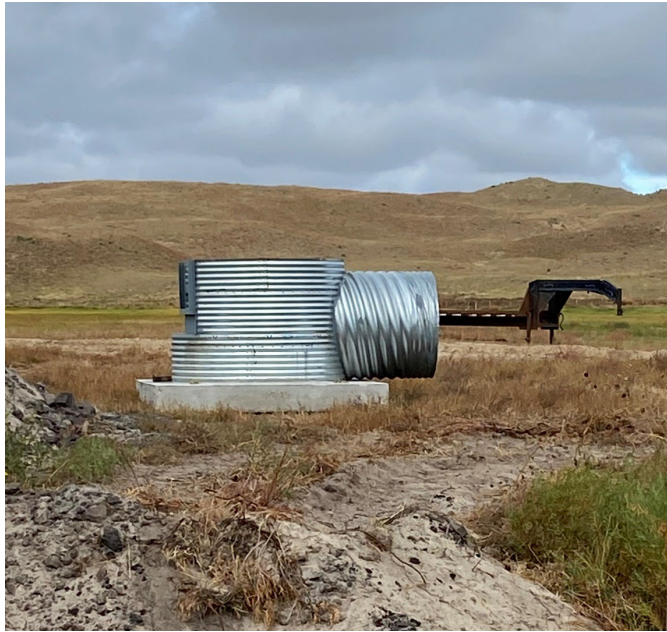
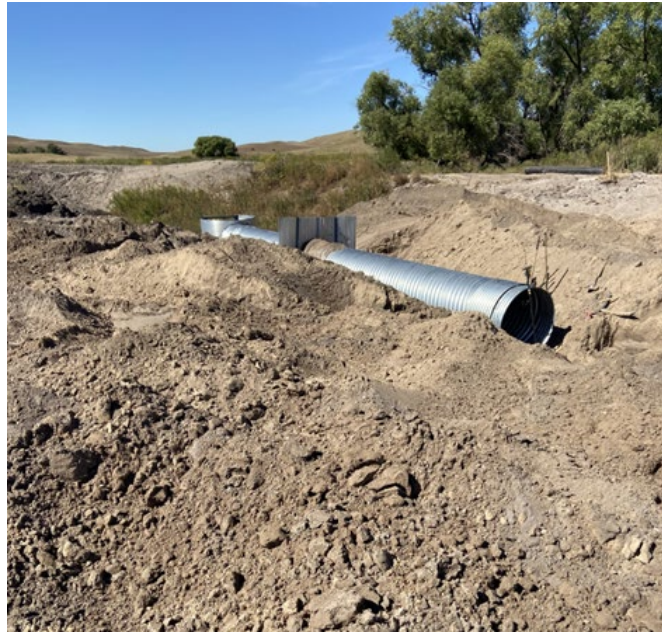
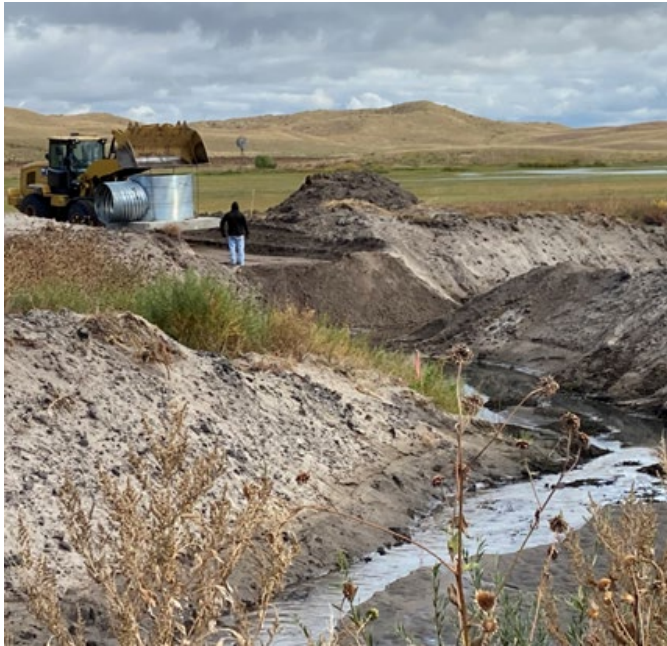
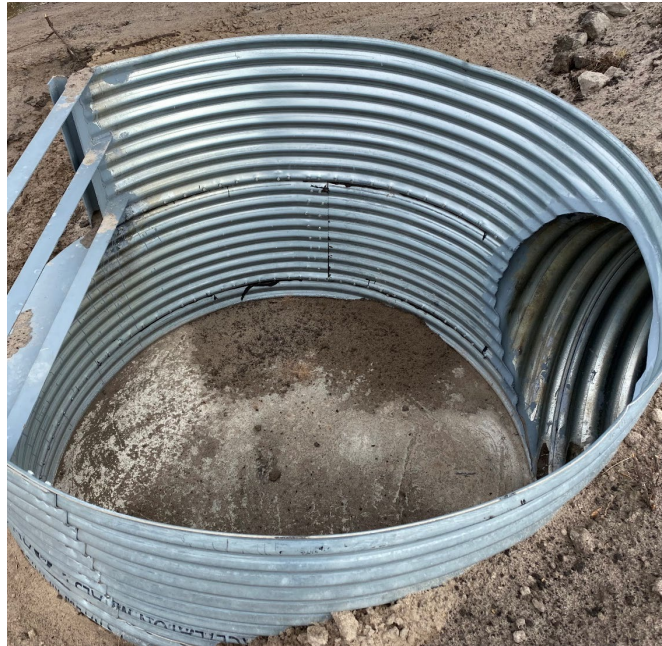
Stop-Log Riser Tube Structures

- Install stop-log structures with a wing dike
- Excavate auxiliary spillway
- Reshape incised streambank

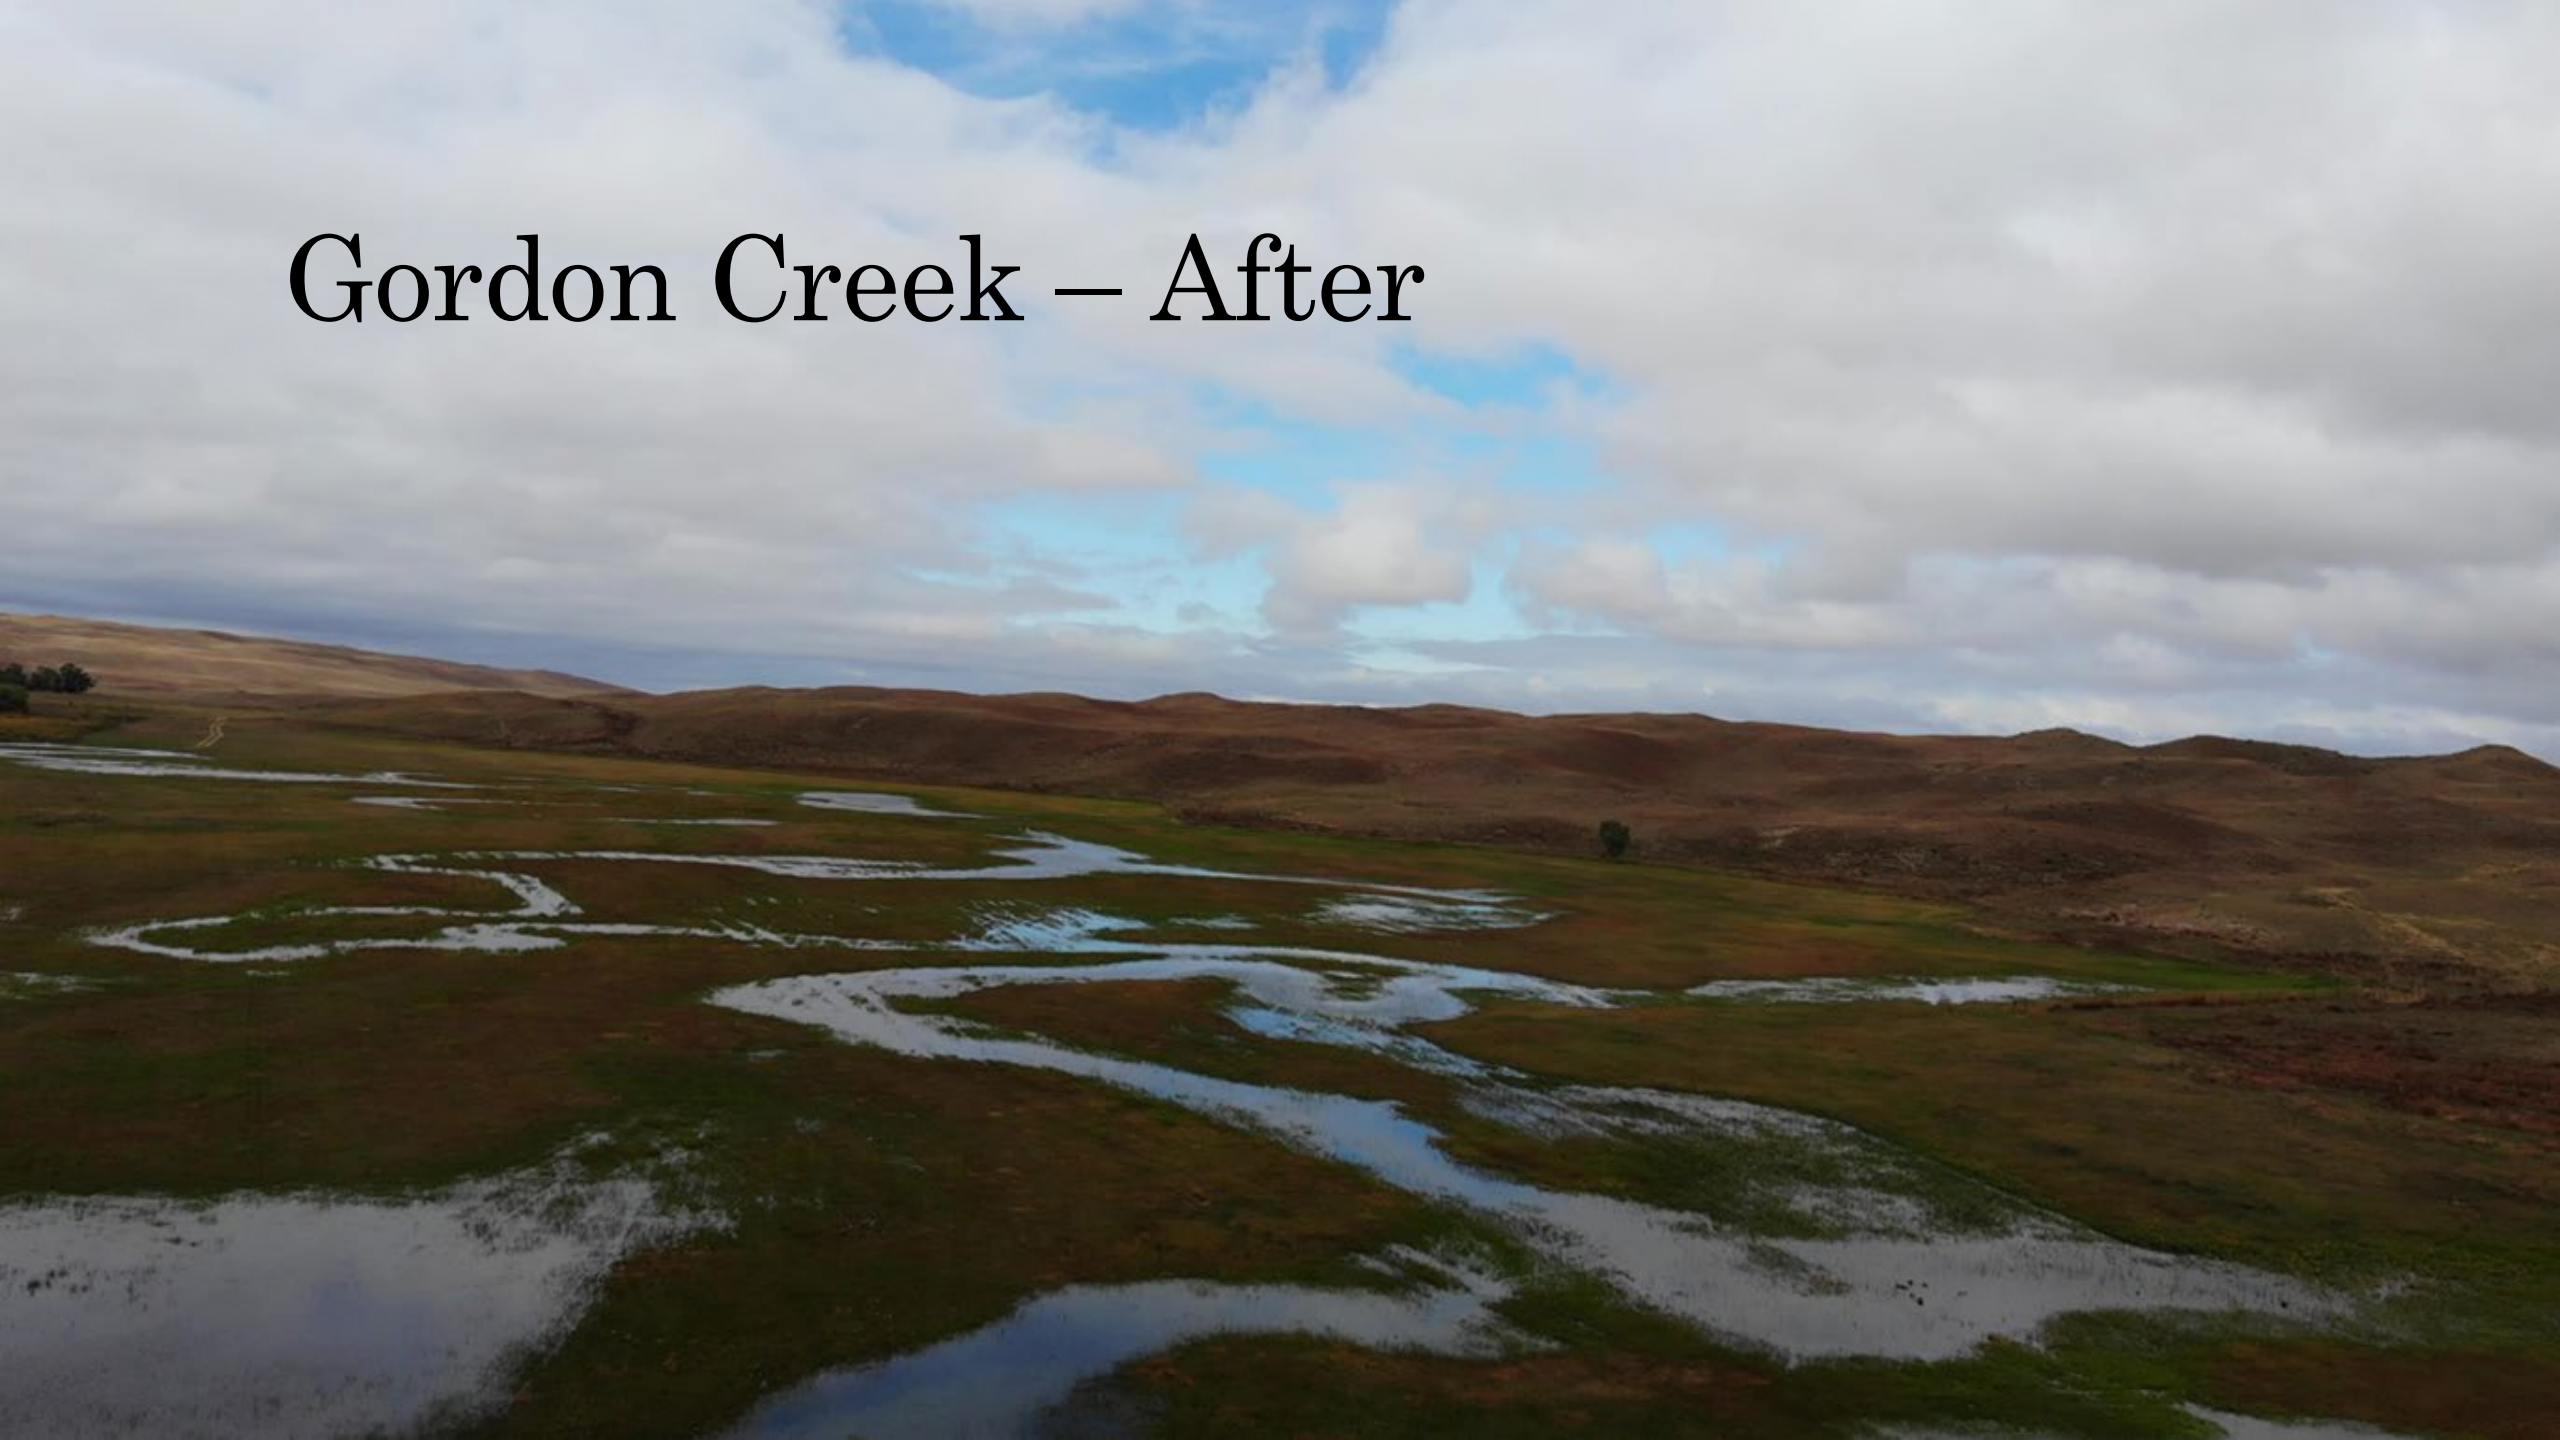
Gordon Creek – After

An aerial photograph showing a wide, shallow river valley. The river flows from the left towards the right. The valley floor is a mix of brownish-grey soil and patches of green vegetation. The surrounding hills are also covered in sparse green vegetation. The overall appearance is that of a natural, undisturbed river system.
